COASTAL EROSION AT PAEKAKARIKI

WELLINGTON'S WEST COAST

FEBRUARY 1980.

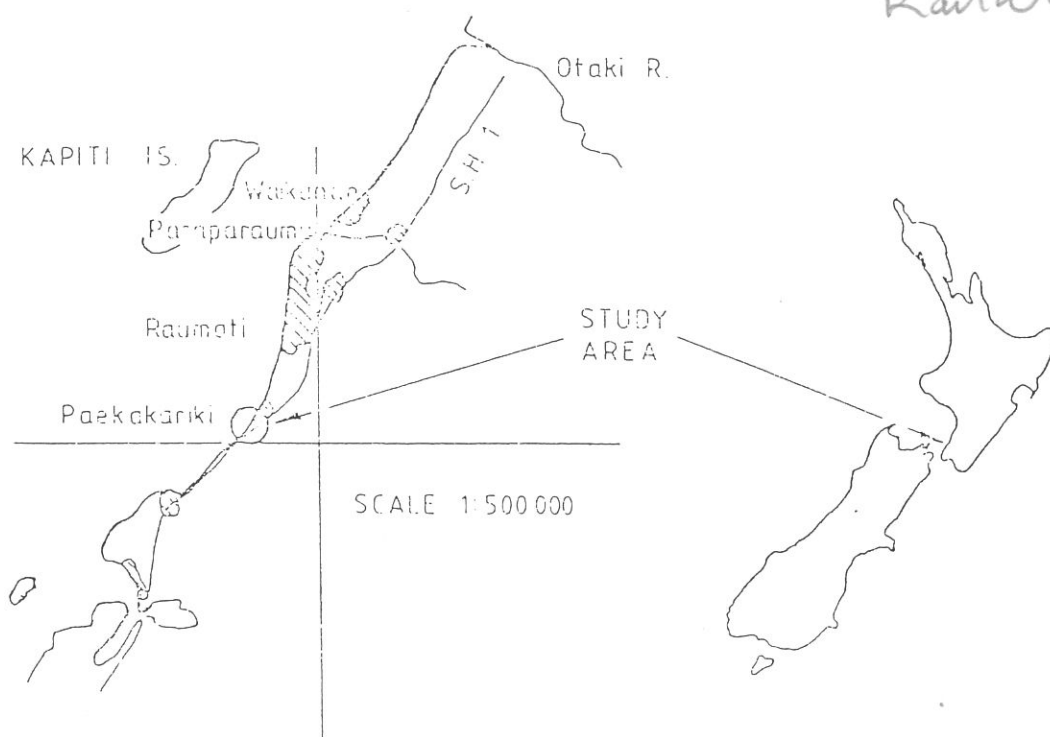
**FIGURE 1**

LOCATION OF INVESTIGATED COAST AT PAKAKARIKI.  
 OBLIQUE ARIAL PHOTO TAKEN 18 APRIL 1979 SHOWING  
 THE 13 ENDANGERED HOUSES ALONG AMES ST. EROSION  
 HAS ACCELERATED SINCE PHOTO WAS TAKEN. OUTFLANKED  
 BEACH PROTECTION WORKS WERE CONSTRUCTED IN 1959.

1. Evacuation and removal over the next few months of the 13 New Zealand Government Railways owned houses along the seaward side of Ames Street.

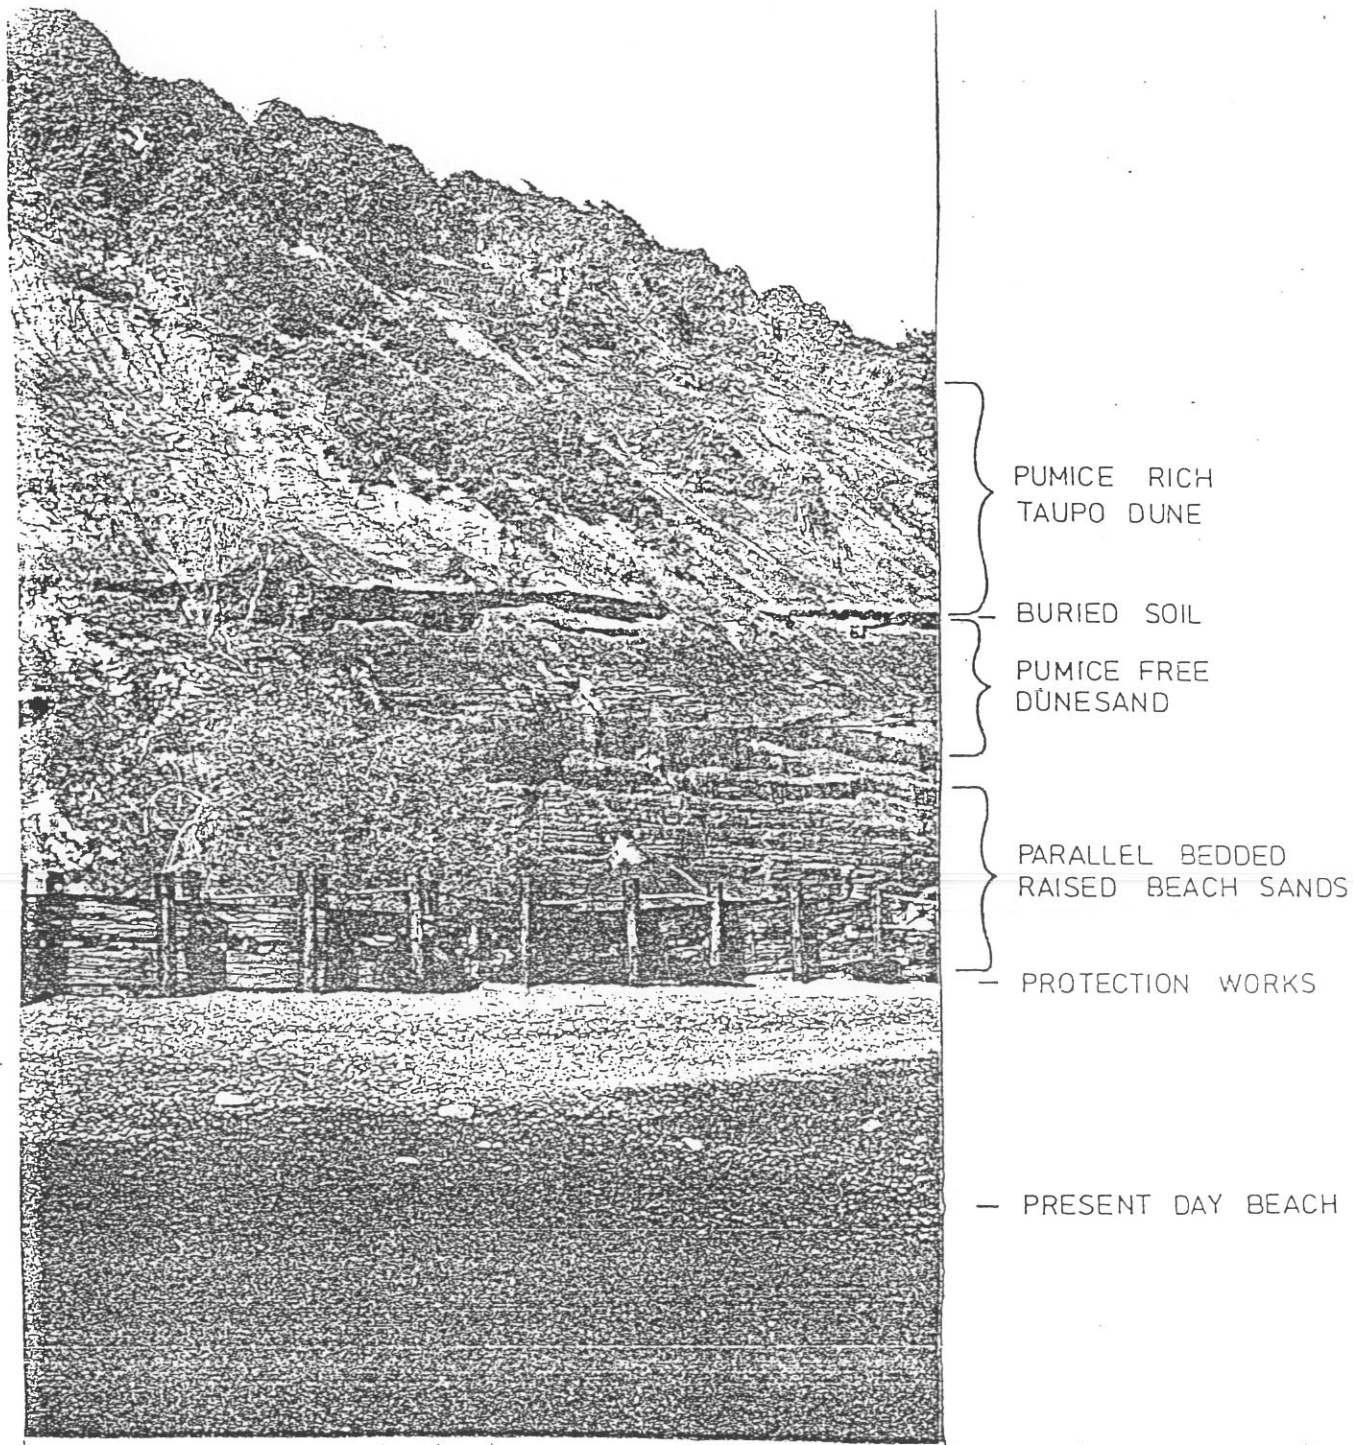
## FIGURE 2

Fig 2 shows an erosion scarp cut in a 30 m high fore-dune (above M S L). From beach level, there are 2.8-3.0 m of parallel-bedded beach deposits overlain by 3-4 m of cross-bedded pumice-free dune sand capped by a prominent horizon representing a buried soil. The ancient soil horizon is overlain by 14-18 m of cross-bedded pumice rich dune sand deposited soon after the Taupo eruption of A D 150. The present-day soil is formed on the Taupo dune sand.

The stratigraphic evidence (Fig 2) reveals two important points. Firstly, the presently eroding shoreline at Paekakariki was advancing from accretion up to, and for some time after the Taupo eruption. According to Gibb (1978), the trend of accretion reversed to net erosion between A D 150 and 1874. Factors causing this significant reversal are discussed later.

PHOTO TAKEN JULY 1979 SHOWING STRATIGRAPHY IN EROSION SCARP ALONG THE FOREDUNE ADJACENT TO ARNES ST., PAKAKARIKI. ABOUT 12m EROSION HAS TAKEN PLACE HERE BETWEEN DECEMBER 1978 AND DECEMBER 1979.

Adjacent to Ames Street, the rail protection work (constructed 1959) although adequate for the period 1959-1978 has become inadequate since December 1978. In March 1979 logs were placed between the rails (Fig 2) but they have failed to prevent wave action from sucking dune sand through the gaps between the logs.

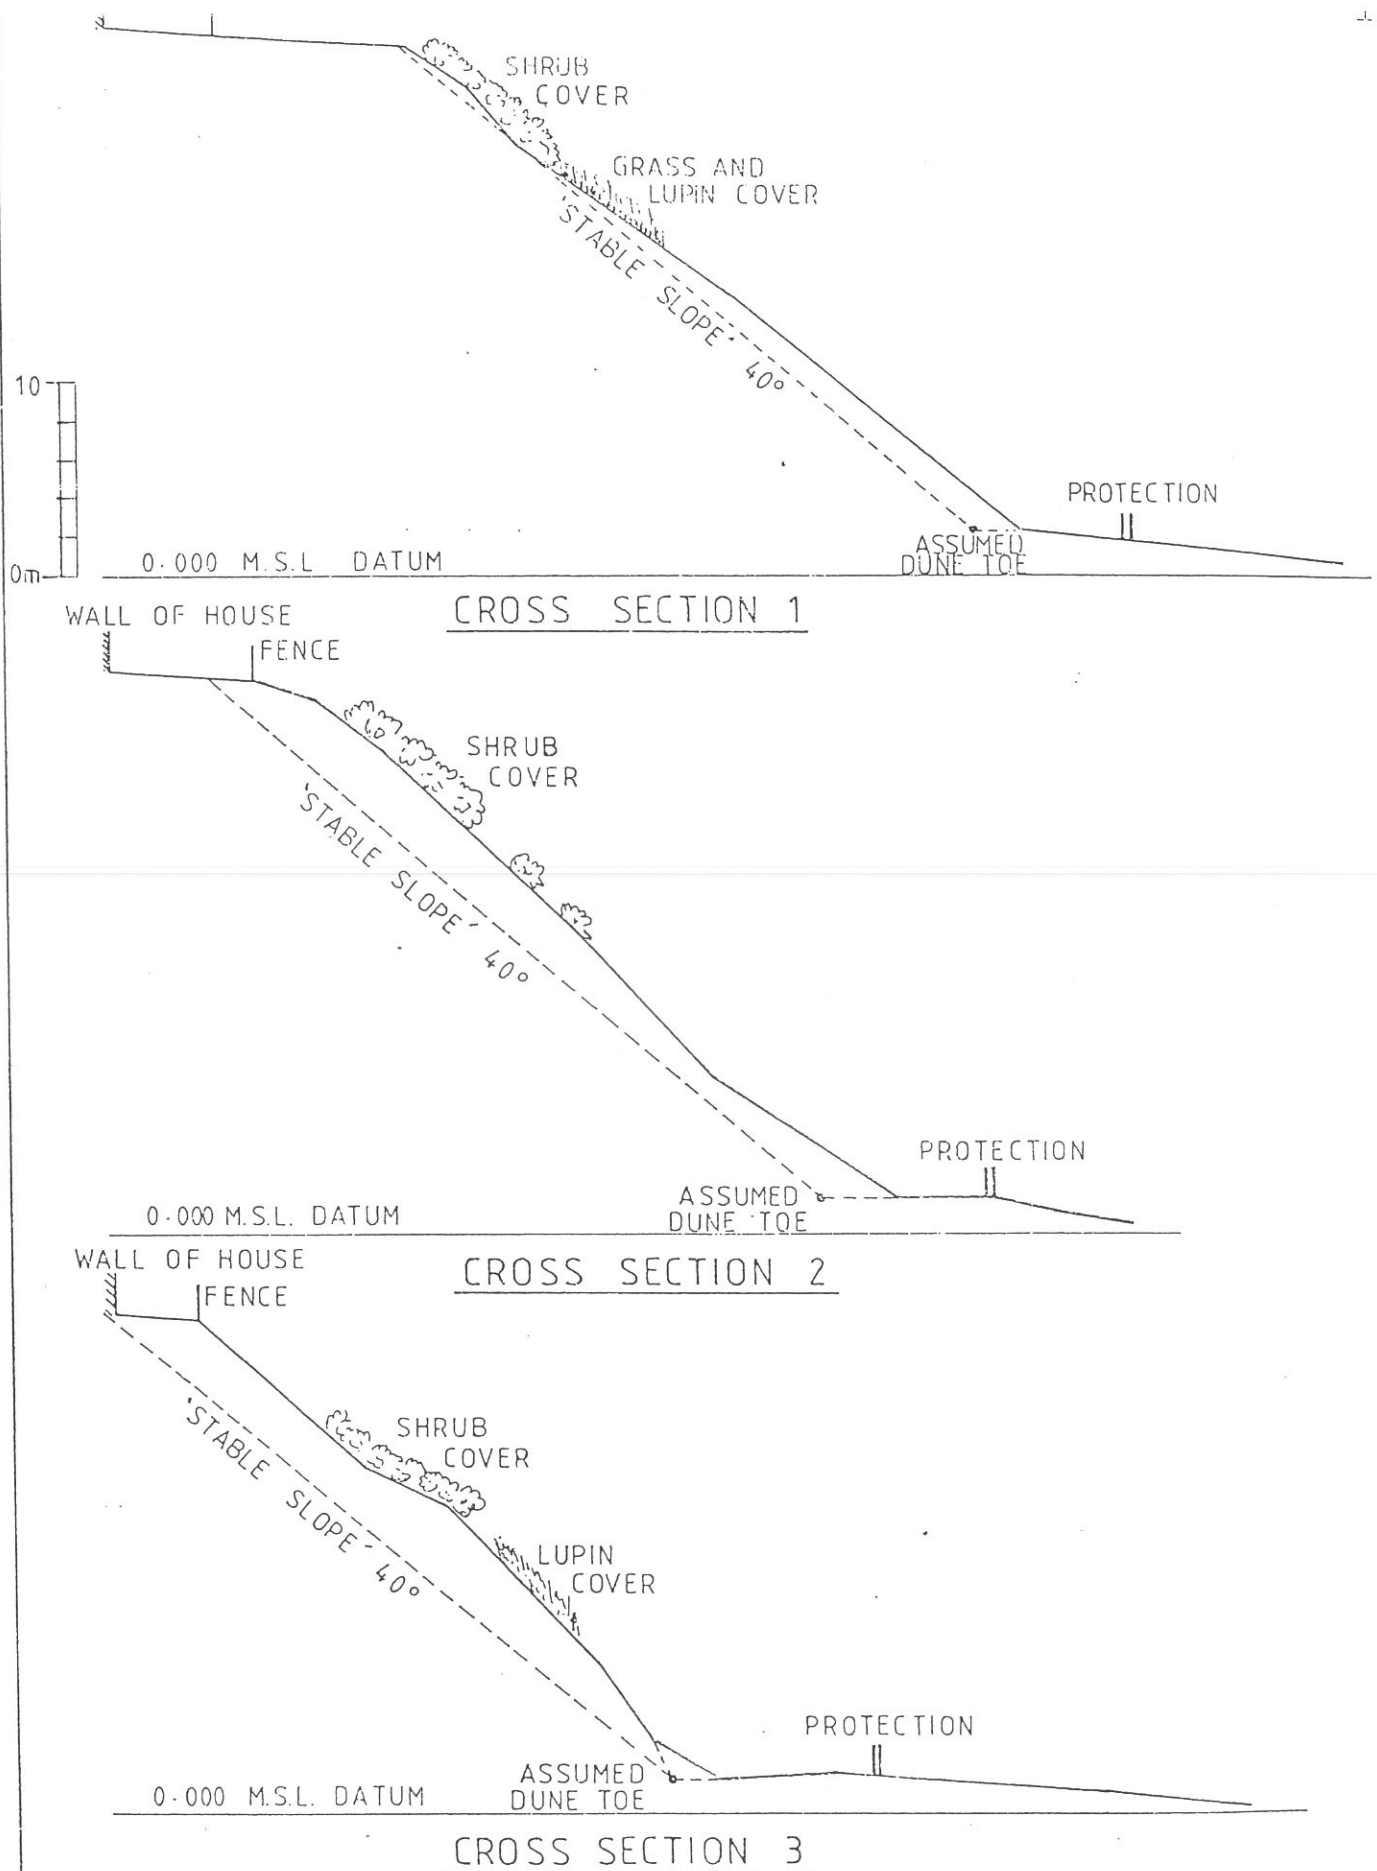
**FIGURE 4**

CROSS-SECTIONS SURVEYED IN AUGUST 1979 OPPOSITE AMES STREET. POSITION SHOWN ON PLAN D.S.159 SHT.1. PROJECTED SLOPE OF 40° REPRESENTS THE STABLE SLOPE THE FOREDUNE IS LIKELY TO ADOPT. POSITION OF DUNE TOE IS INFERRED BY PROJECTING EXISTING EROSION SCARP DOWNWARDS.

The three survey cross-sections (surveyed August 1979) shown on Plan D S 159, Sheet 3, indicate that the existing erosion scarps are standing at maximum angles of  $44^{\circ}$ - $48^{\circ}$ . Fans formed from collapse of the oversteepened erosion scarps typically occur at angles of  $33^{\circ}$ - $38^{\circ}$ . The loose sand forming the fans is being removed by wave action exposing the dune toe to further erosion.

Our observations indicate that the average range of existing slopes is from about  $35^{\circ}$  for loose sand to  $45^{\circ}$  for partially consolidated vegetated sand. Average existing slope angles (slope of line from present dune toe to crest) on the three cross-sections are  $38^{\circ}$ ,  $39^{\circ}$  and  $41^{\circ}$ . In order to predict the likely extent of retreat of the foredunes and the subsequent threat to the houses along Ames Street, an overall slope angle of  $40^{\circ}$  is adopted and projected upwards from the present dune toe to intersect the dune crest on all three cross-sections (Fig 4). Fig 4 shows that where houses are close to the seaward edge of the foredune (4 m on cross-section 3) the projected "stable slope" indicates that they are in immediate danger of collapsing on to the beach. Considering that 7-12 m of erosion has taken place over the last twelve months plus the inadequacy of the existing coastal protection, the 13 New Zealand Government Railways owned houses at the south end of Ames Street (Fig 1) could be in imminent danger of collapse.

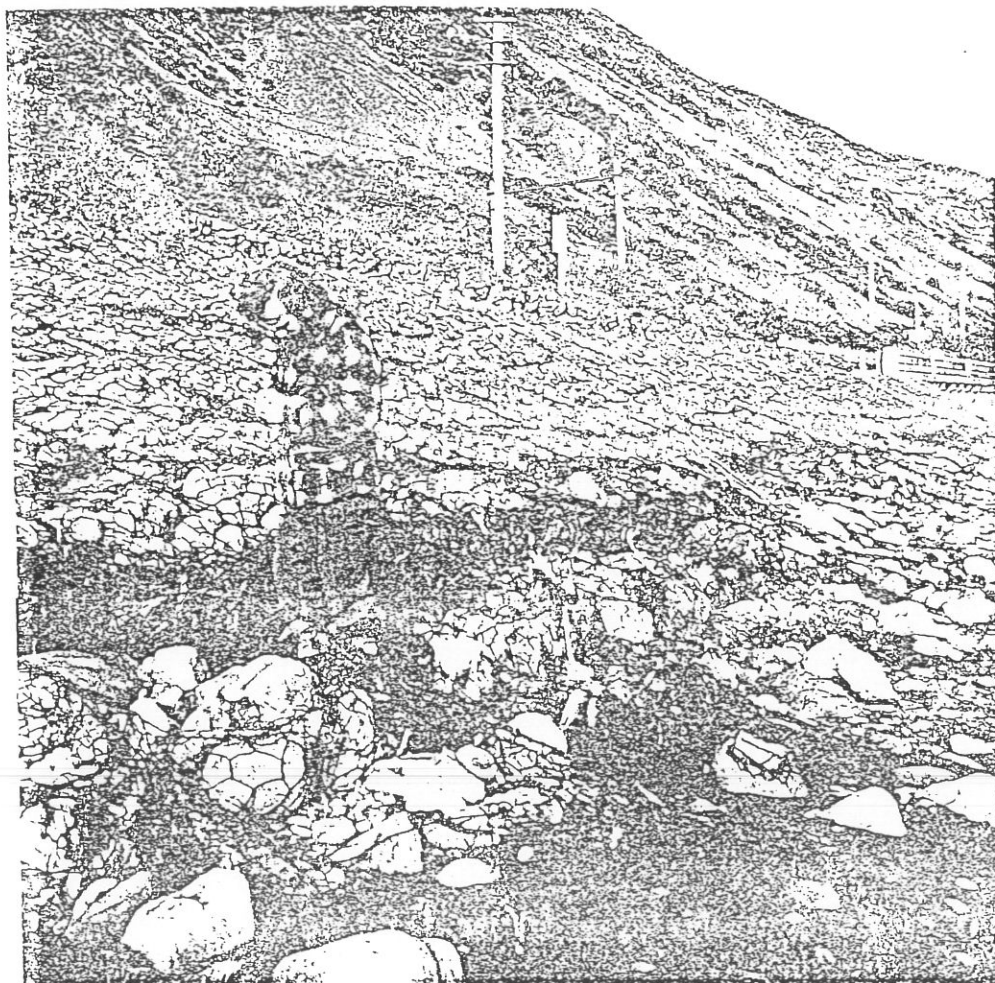
FIGURE 5

Our observations show that most, if not all the existing coastal protection works at Paekakariki are inadequate. The gabion protection work (constructed 1972) protecting State Highway 1 is being destroyed along the toe by abrasion from mobile beach gravels (Fig 5). The wire baskets are breaking up under impact of boulders during heavy seas.

PHOTO TAKEN JULY 1979 LOOKING SOUTH SHOWING  
DAMAGE TO GABION BASKETS CONSTRUCTED IN 1972.  
THE SCREE SEEN ABOVE IS RECOMMENDED AS A  
SOURCE OF BEACH GRAVEL.

We conclude that the scree material in the quarry is likely to be quite adequate for beach replenishment at Paekakariki. It would be unwise to use the weathered greywacke material that is presently being quarried at Paraparaumu for the Raumati seawall. The softer weathered material is highly vulnerable to abrasion.

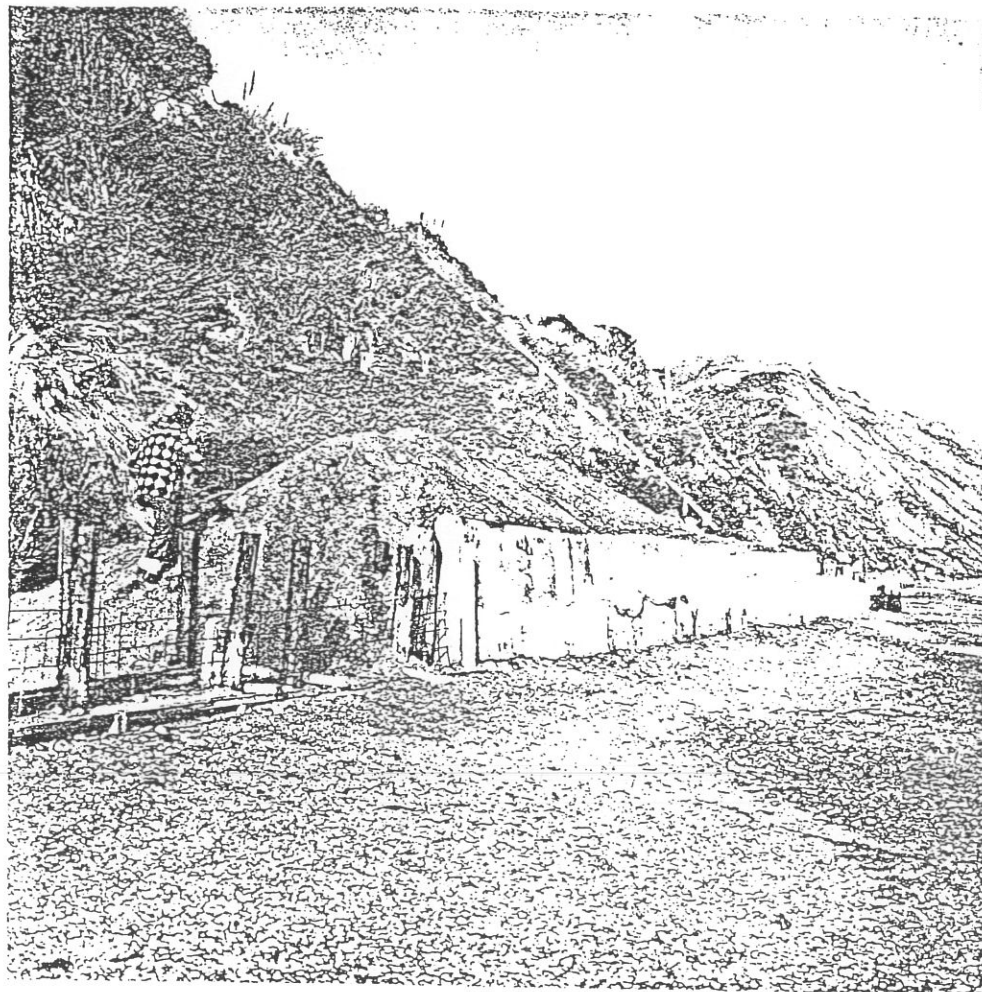
FIGURE 6

X North of Ames Street property owners have constructed their own seawalls from cement and car tyres (Fig 6). In most cases the concrete is made from sand off the beach and therefore may have little strength. As a result the walls are undermined and collapsing in several places. Many of the walls are backfilled with sand illegally taken off the adjacent beach. This practice can only exacerbate the erosion as the beach is already losing sediment. 7

PHOTO TAKEN JULY 1979 LOOKING SOUTH SHOWING  
PRIVATELY CONSTRUCTED CONCRETE SEAWALLS. WALL  
IN FOREGROUND IS BACKFILLED WITH SAND ILLEGALLY  
TAKEN OFF ADJACENT BEACH.

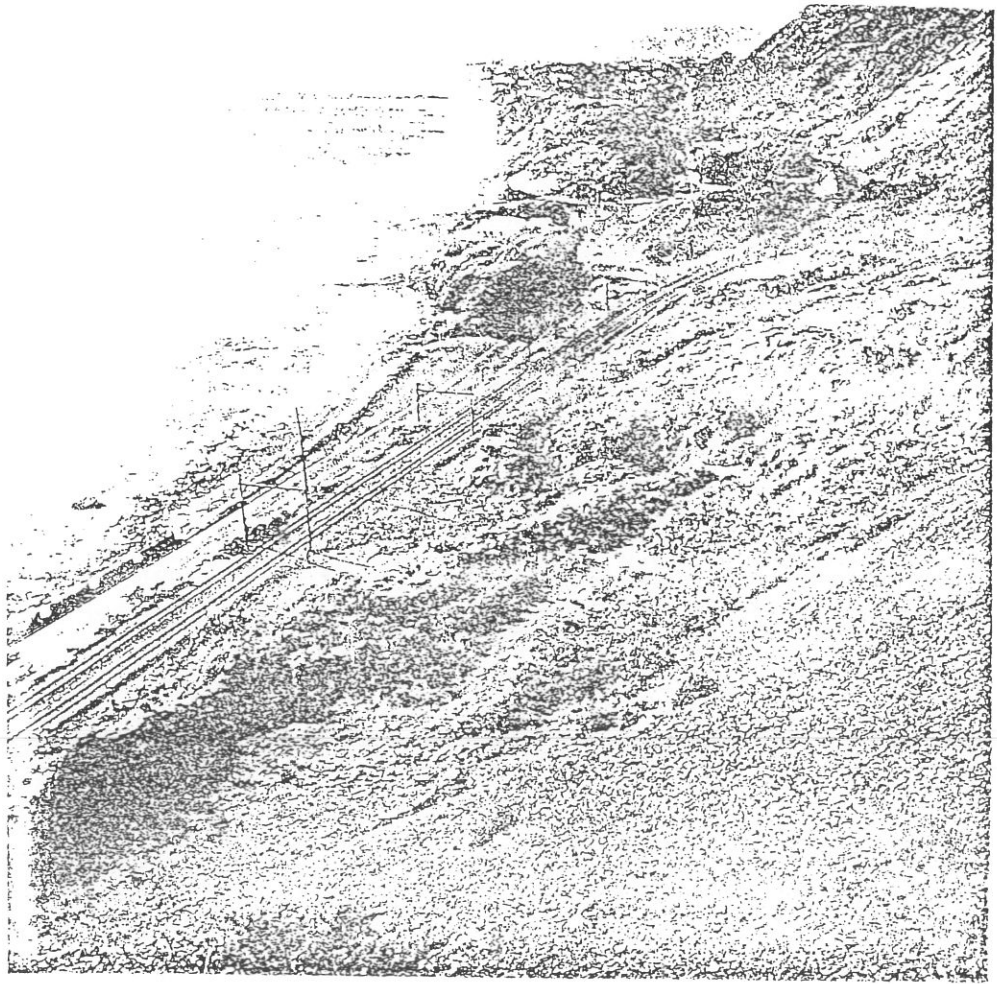
### FIGURE 7

The sand fed to the beach from the eroding foredune does not remain on the beach. The sand is transported seaward during storm activity and is deposited as a longshore bar. Unlike the coastline north of Paraparaumu the sand bar does not return to the beach during calmer weather. Observations during northwesterly gales indicate that the sand migrates southwards in the surf-zone and then offshore in a large rip current about 100 m south of the Fisherman's Table Restaurant. (see Fig 7).

PHOTO TAKEN JULY 1979 FROM THE QUARRY LOOKING  
NORTHWARDS ALONG THE PAKAKARIKI COASTLINE. RAILWAY  
AND SH.1 ARE IN THE FOREGROUND. FISHERMAN'S TABLE  
RESTAURANT MIDDLE TOP OF PHOTO AND RAIL AND  
LOG PROTECTION WORK BEYOND THE RESTAURANT. NOTE  
THE OVERGROWN ROAD ACCESS TO THE BASE OF THE  
SCREE AND ROAD ACCESS ACROSS RAILWAY LINE.  
DEPOSITION POINTS FOR SCREE GRAVEL ONTO BEACH  
ARE VISIBLE NORTH AND SOUTH OF THE RESTAURANT

The most suitable material to replenish the beach is gravel. For this reason we investigated an abandoned quarry a few hundred metres south of the problem area (Fig 7). Fig 7 is a view from the quarry looking north. The quarry is accessible by road to the base of the scree and is ideally situated in relation to supplying the beach by the Fisherman's Table Restaurant. u
