COASTAL EROSION AT PAEKAKARIKI

WELLINGTON'S WEST COAST

FEBRUARY 1980.

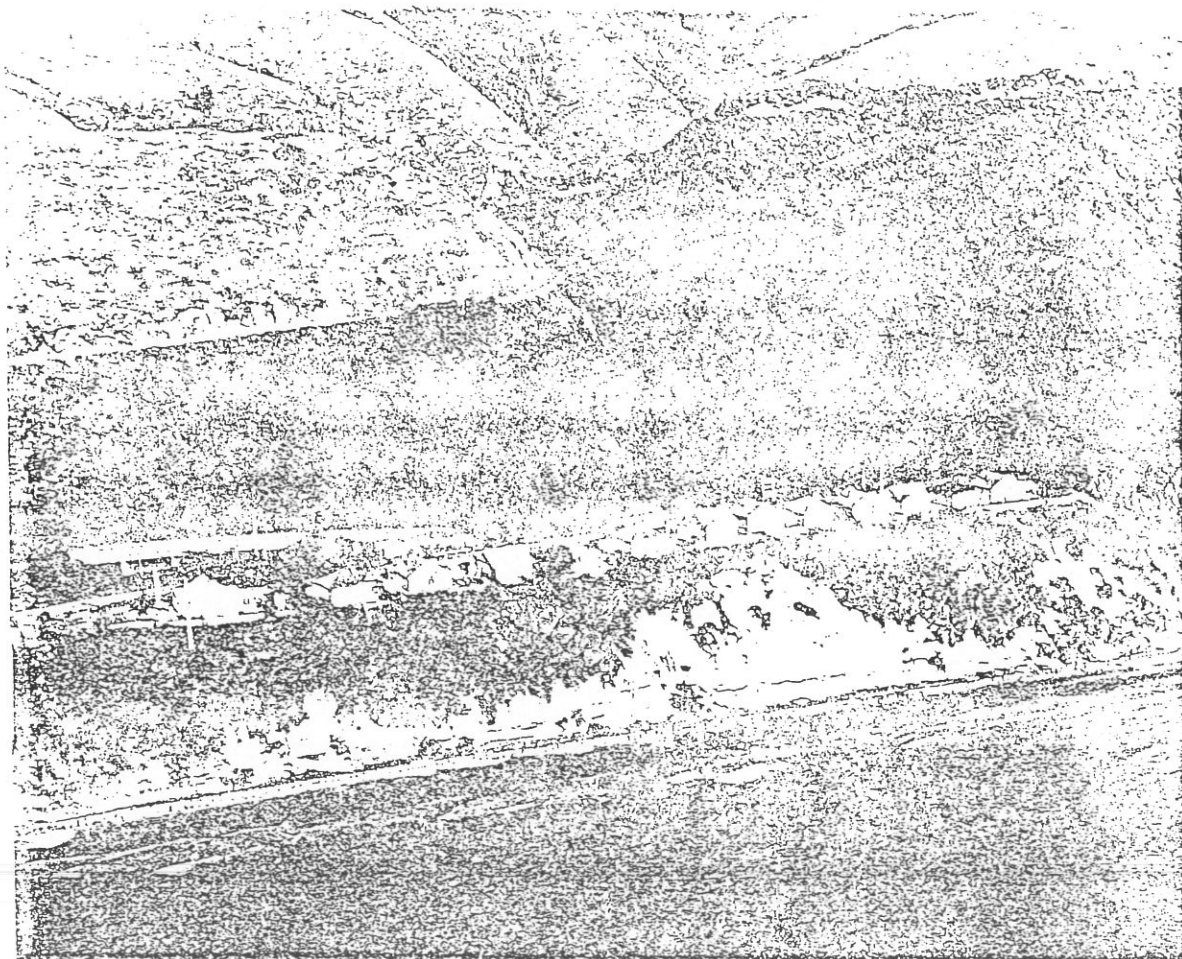
**FIGURE 1**

LOCATION OF INVESTIGATED COAST AT PAKAKARIKI.  
 OBLIQUE ARIAL PHOTO TAKEN 18 APRIL 1979 SHOWING  
 THE 13 ENDANGERED HOUSES ALONG AMES ST. EROSION  
 HAS ACCELERATED SINCE PHOTO WAS TAKEN. OUTFLANKED  
 BEACH PROTECTION WORKS WERE CONSTRUCTED IN 1959.
